# Technical Bulletin

94 07 02 May 10, 2007 2012799 Supersedes T. B. Group 94 number 06-17 dated Nov. 3, 2006 due to updated part and part installation procedure.

Headlamp Inoperative, Adaptive HID Xenon System

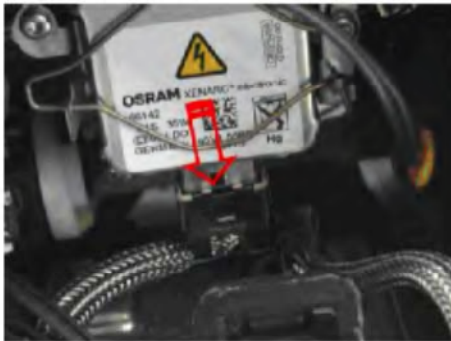
The factory harness routing may cause too much tension on the HID Bi-Xenon headlamp connector. When adaptive action (movement) is enabled, the HID Bi-Xenon headlamp wiring harness may disconnect from the HID Bi-Xenon bulb connector.

Install retainer clip 3D0941160A on securing bar.

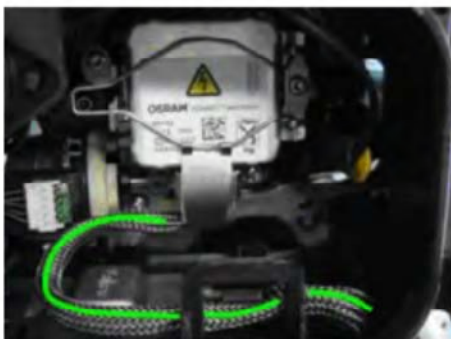
Proper harness routing orientation -arrow-.

When connecting the harness connector, ensure the cable is routed correctly and free of twists and kinks.
